Bord na Móna

Attymon Bog

Cutaway Bog Decommissioning and Rehabilitation Plan

2024

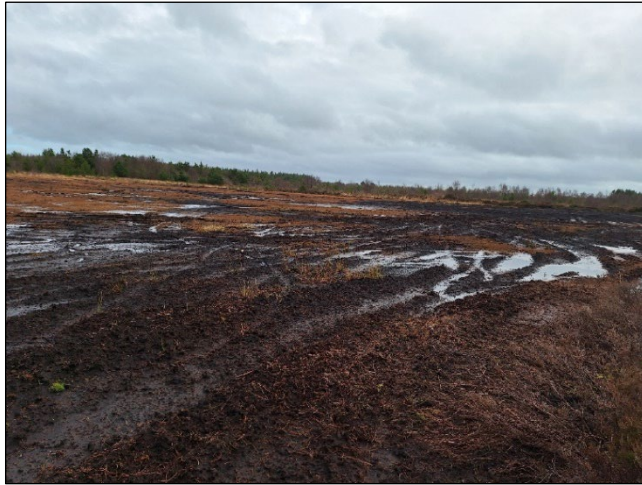
Plate 3-1 Cutover dominated by bare peat and pioneer vegetation to the north-western corner of the site.

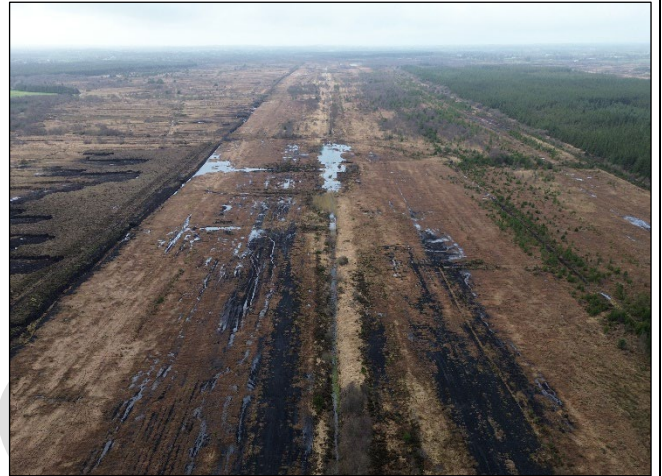
Plate 3-2 Pioneer vegetation and bare peat south of the conifer plantation. Remnant raised bog occurs along the southern border.

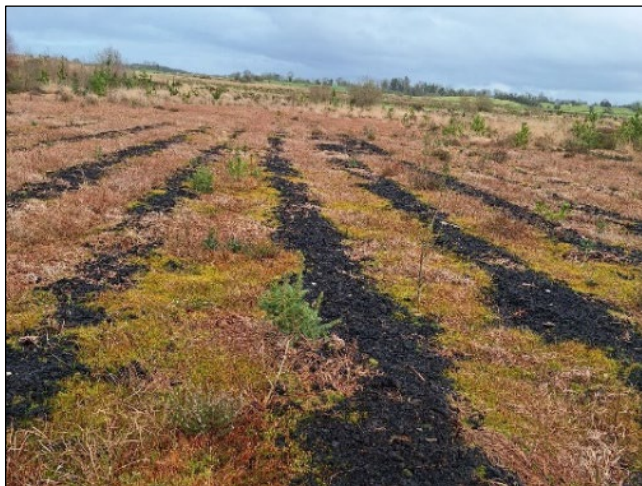
Plate 3-3 Bare peat and pioneer vegetation in the SE of the northern lobe.

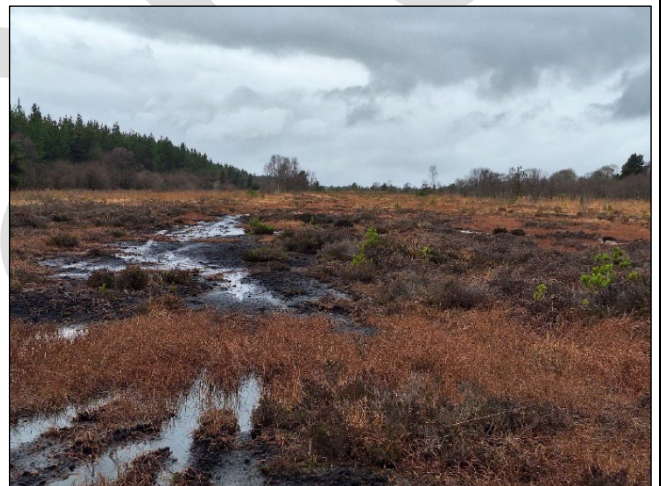
Plate 3-4 Cutover dominated by pioneer vegetation, bare peat and occasional scrub to the north of the conifer plantation within the main lobe.
