Bord na Móna

Cloonshannagh Bog

**Cutaway Bog Decommissioning and
Rehabilitation Plan**

2024

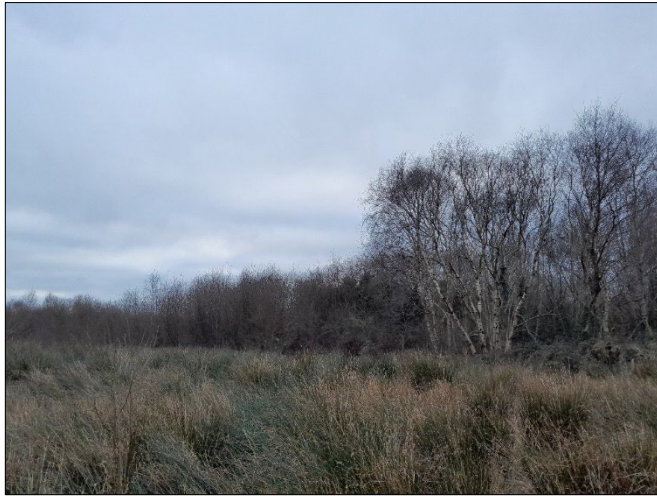
Birch woodland (BirWD)/Scrub in the northeast of Cloonshannagh with pioneer Juncus effusus in the foreground.

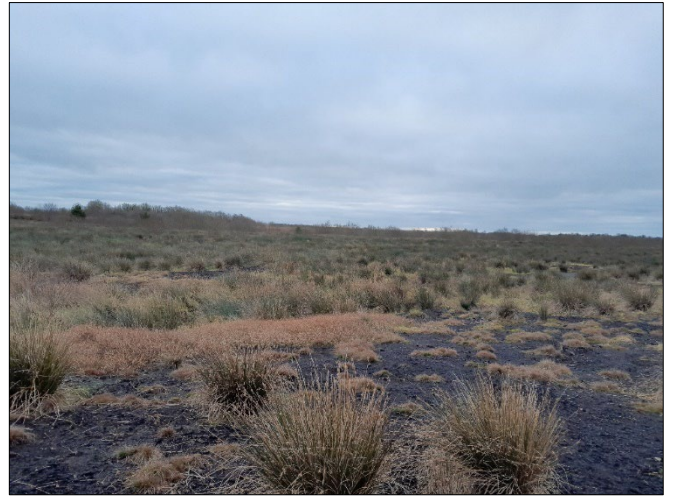
Cutover with pioneer vegetation dominated by Juncus effusus in the northern part of the Bog.

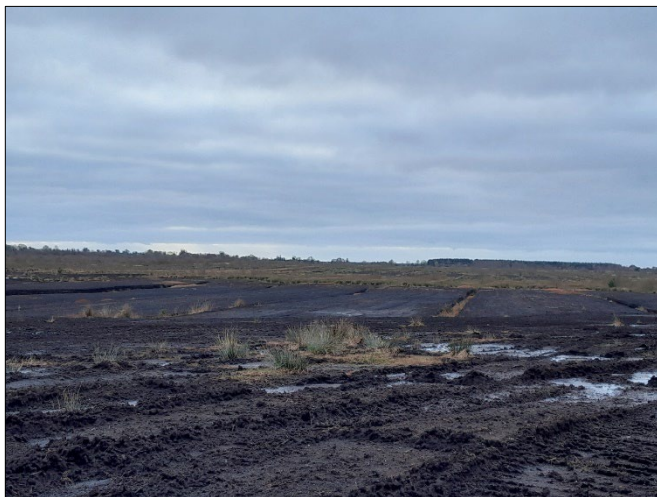
Cutover dominated by bare peat and with pioneer vegetation in the background.

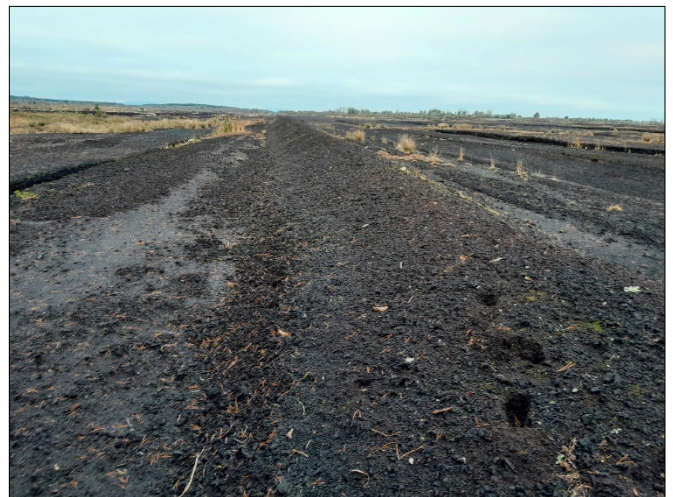
Cutover dominated by bare peat with remaining peat stockpile.
