Bord na Móna

Gowla Bog

**Cutaway Bog Decommissioning and
Rehabilitation Plan**

2024

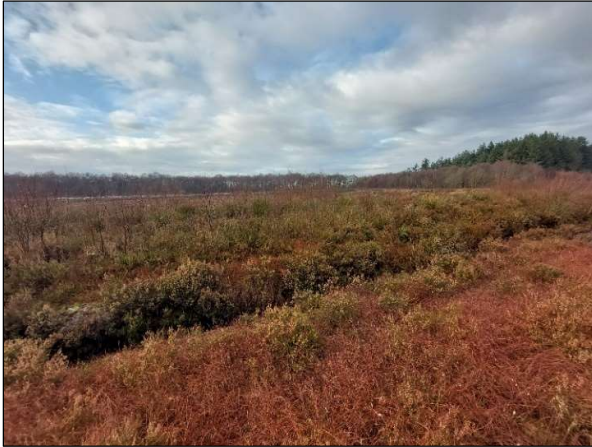
Plate 3-1 Vegetated high fields in the centre of the bog, with abundant dry Heather dominated vegetation, emergent Birch (eBir) and pioneer Eriophorum angustifolium (PEang).

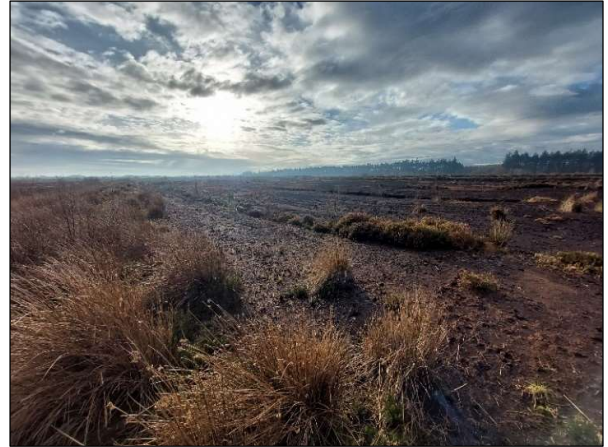
Plate 3-2 View of bare peat dominated cutover in the former production area, pioneer vegetation communities beginning to develop including Juncus effusus community (pJeff) and dry heather dominated vegetation (dHeath).

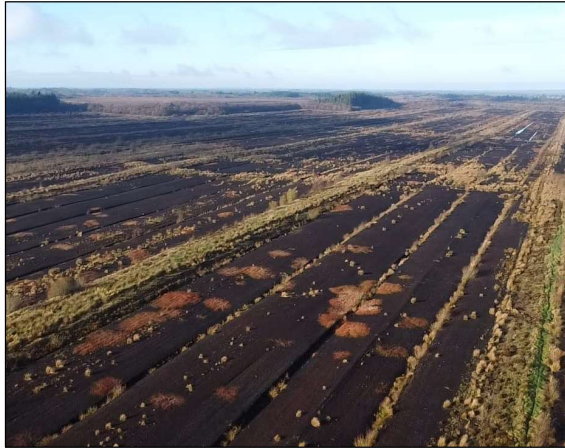
Plate 3-3 Aerial View of Cutaway in the former production area (looking northwest).

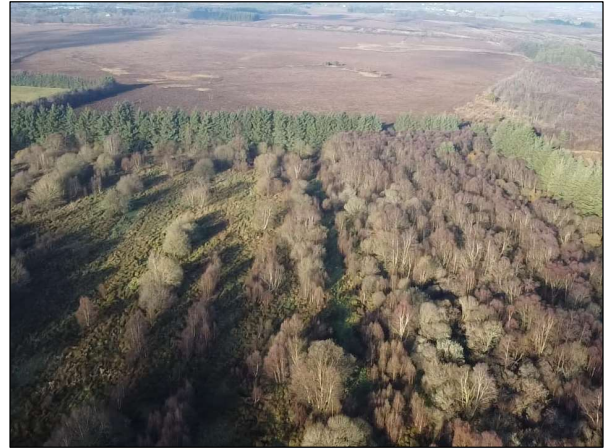
Plate 3-4 Aerial view of Birch woodland/wet grassland in the AW2 area in the SW of Gowla, with view of the raised bog at Castle Ffrench East NHA in the background.

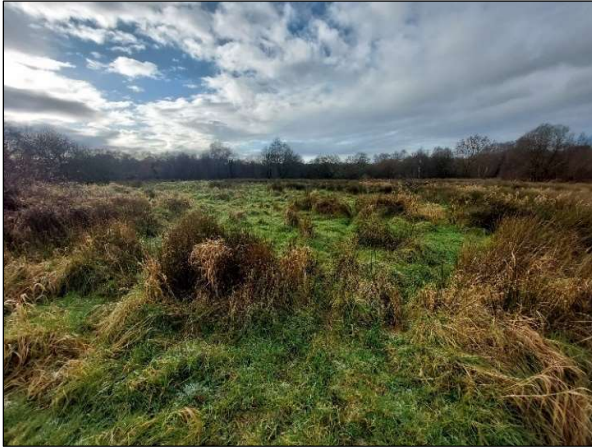
Plate 3-5 Wet grassland in the AW2 area in the SW of Gowla.

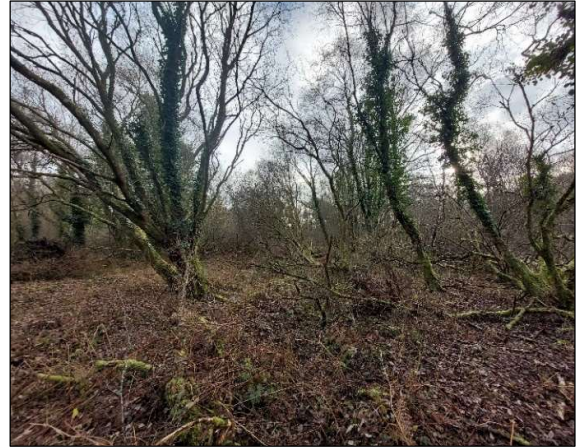
Plate 3-6 Birch Woodland in the AW2 area in the SW of Gowla.

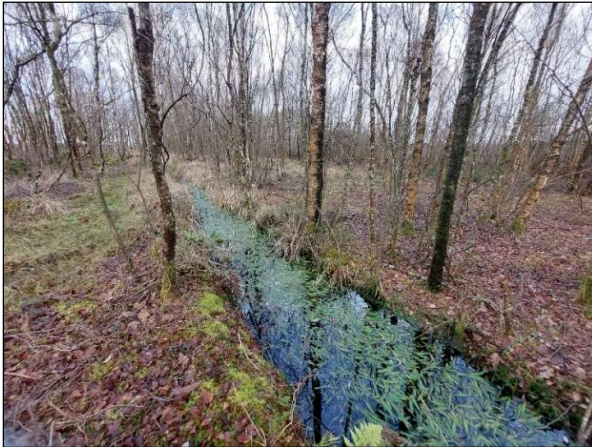
Plate 3-7 Marginal Birch woodland (WN7) in the western part of the bog.

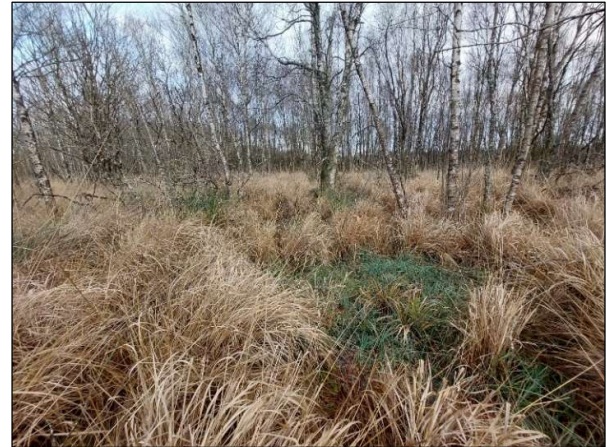
Plate 3-8 Bog Woodland (WN7) along the western margins, grades into raised bog (PB1) habitat.

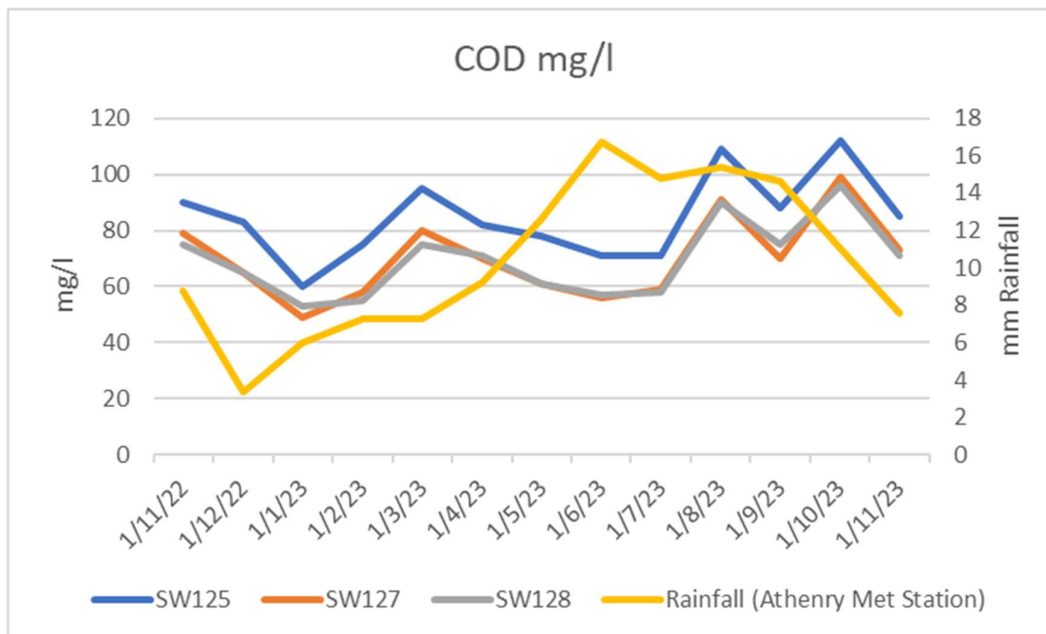
Plate APXIII-2 Gowla COD sampling results
