Bord na Móna

Killashee bog

**Cutaway Bog Decommissioning and
Rehabilitation Plan**

2024

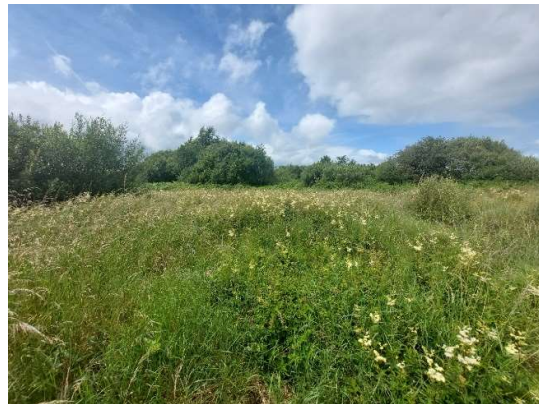
Wet grassland to the north east of the site.

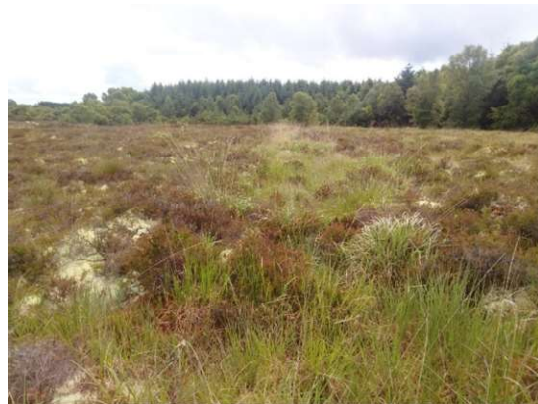
Remnant raised bog to the west of Killashee.

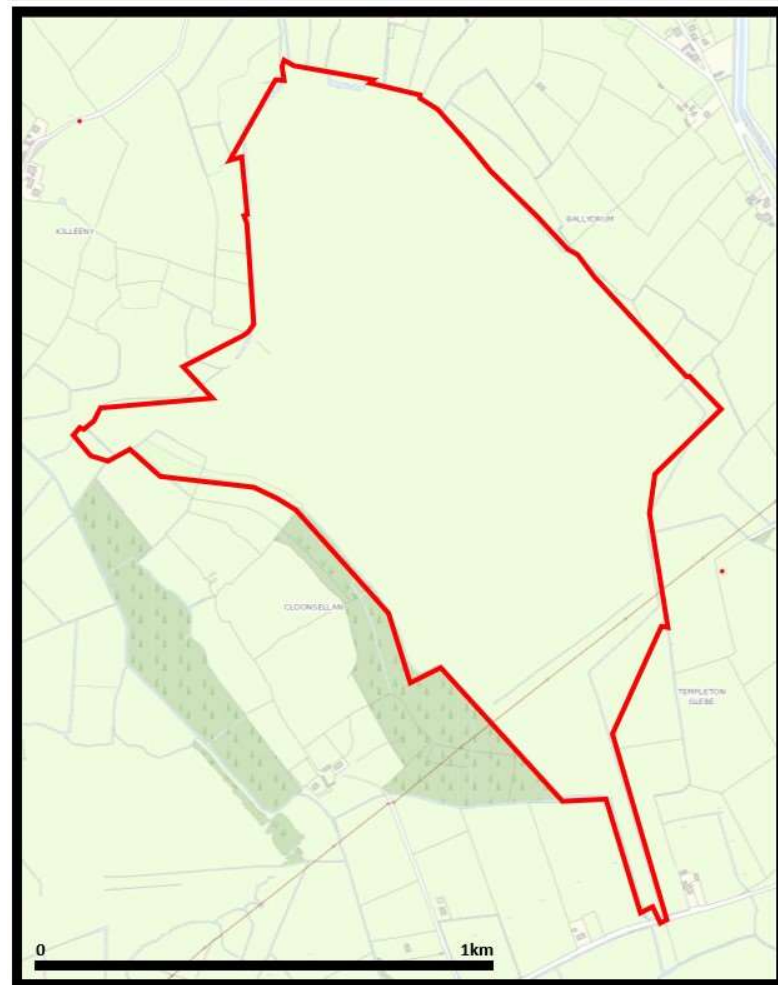
Fig. 3. Killashee Bog, Co. Longford, detail of the Sites and Monuments Record. The proposed rehabilitation area is outlined with the red line.

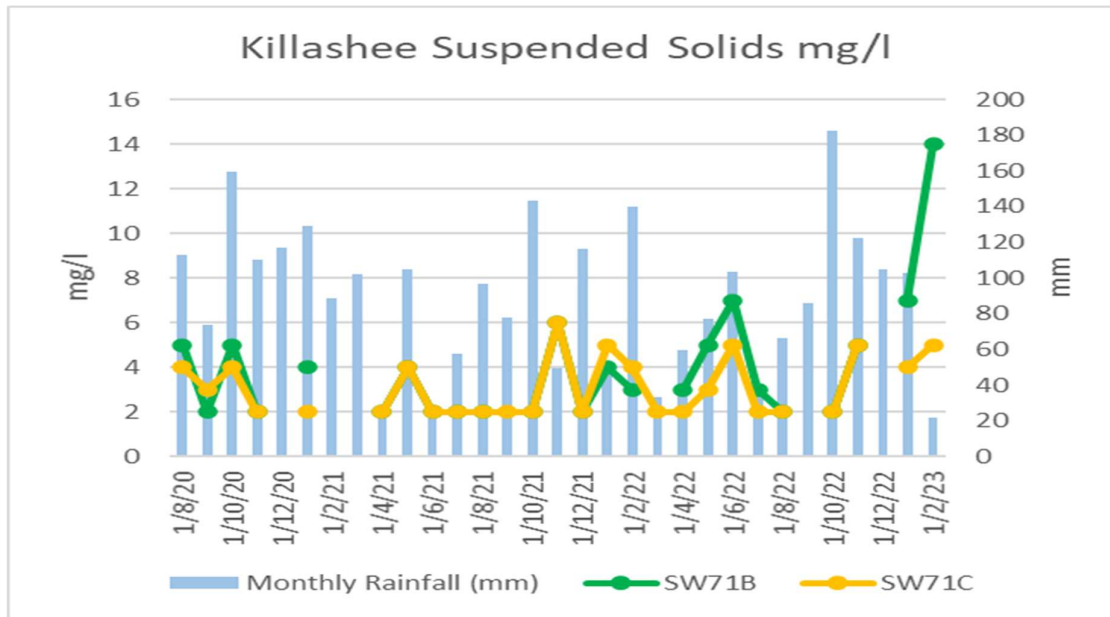
Figure AP13.1. Suspended solids in water sampling at Killashee bog from different discharge points. 35 mg/l is the emission limit value.

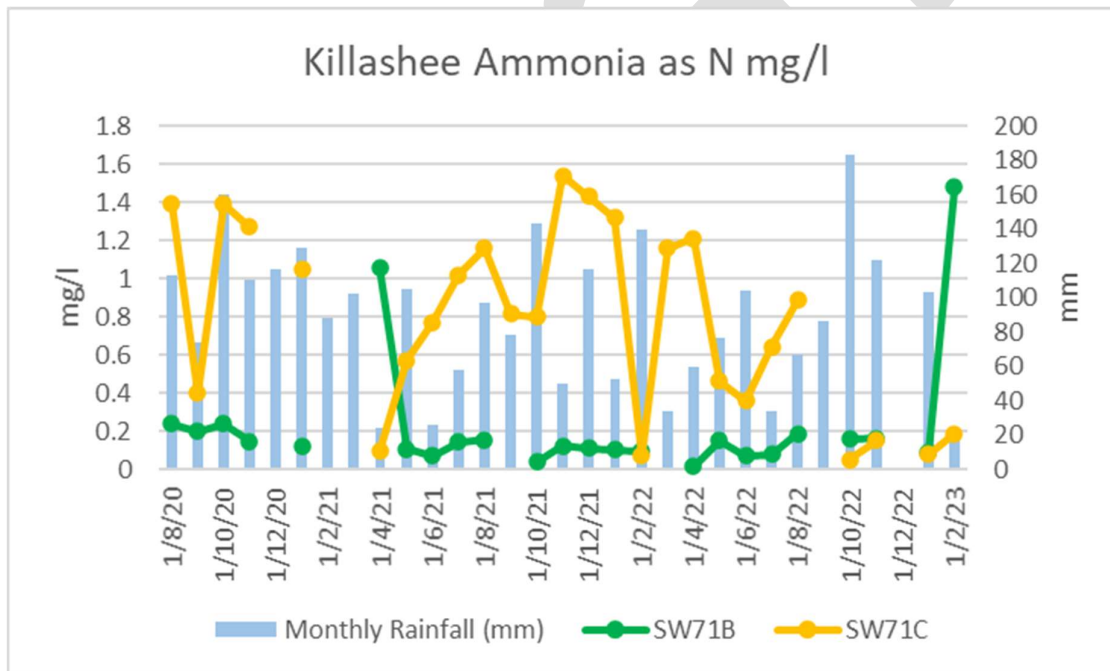
Figure AP13.2. Ammonia concentrations in water sampling from Killashee bog from different discharge points. The main trigger level for ammonia is 1.42mg/l for reporting to EPA.

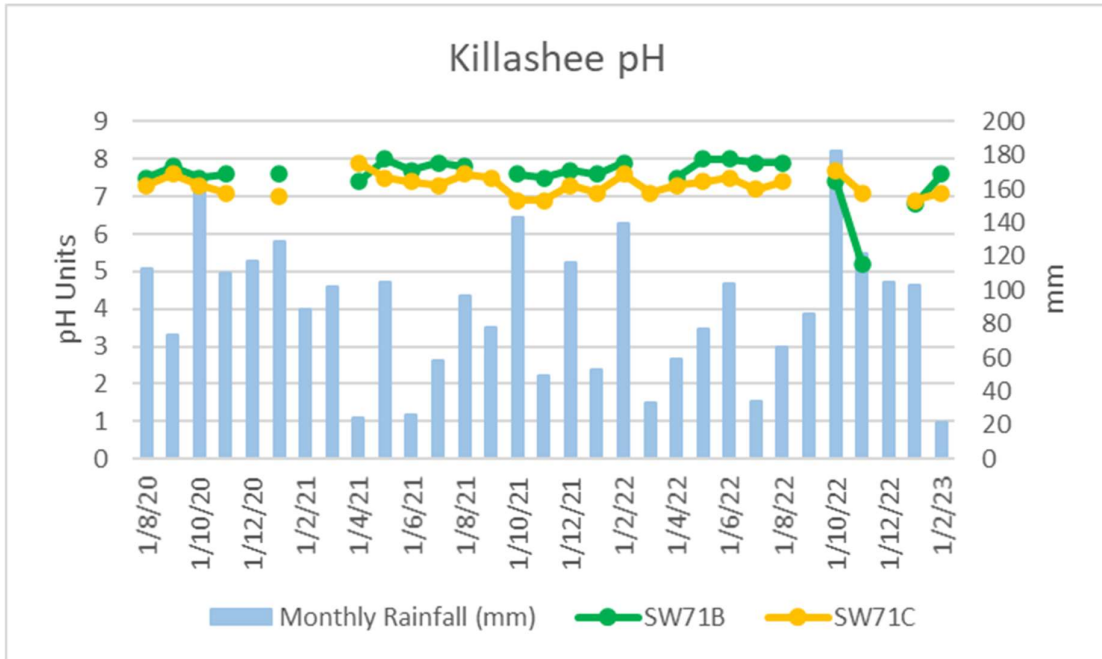
Figure AP13.1. pH in water sampling at Killashee bog from different discharge points.
