# Bord na Móna

## Derrymoylin bog

### Cutaway Bog Decommissioning and Rehabilitation Plan

### 2024

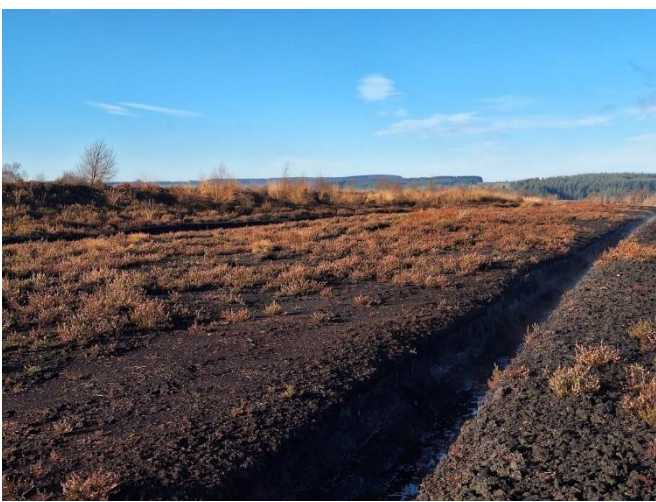
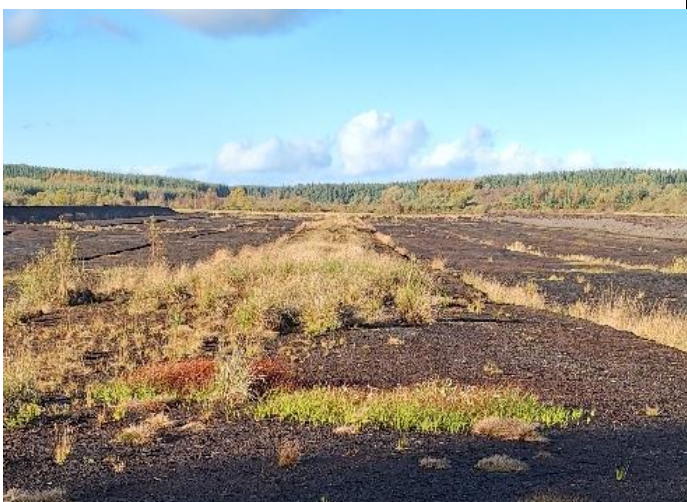
<p><i>Plate 3-1 Example of establishing Heather (dHeath) on residual deep peat within the southeastern lobe of Derrymoylin.</i></p>	<p><i>Plate 3-2 Example of pioneering vegetation (pJeff) on otherwise bare peat dominated cutover bog within the main northern lobe of Derrymoylin bog.</i></p>

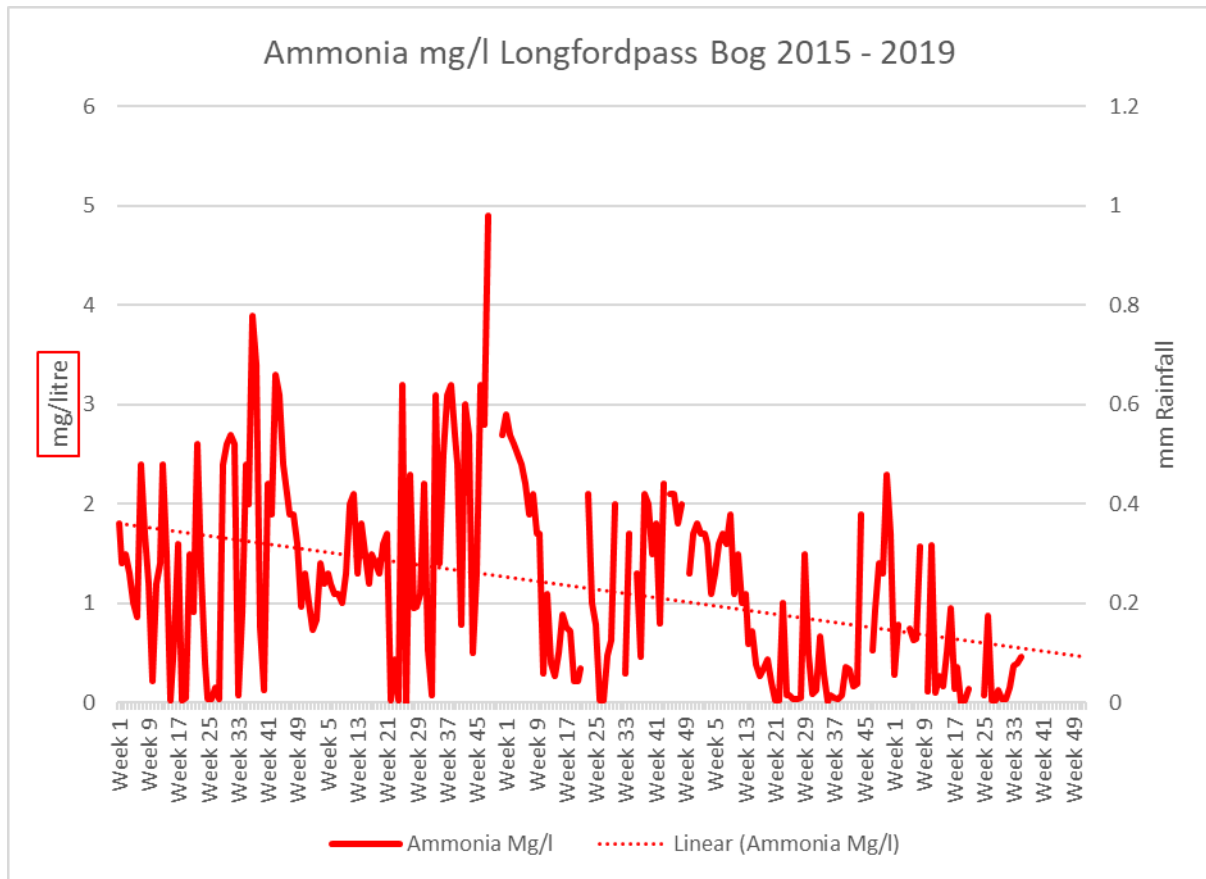
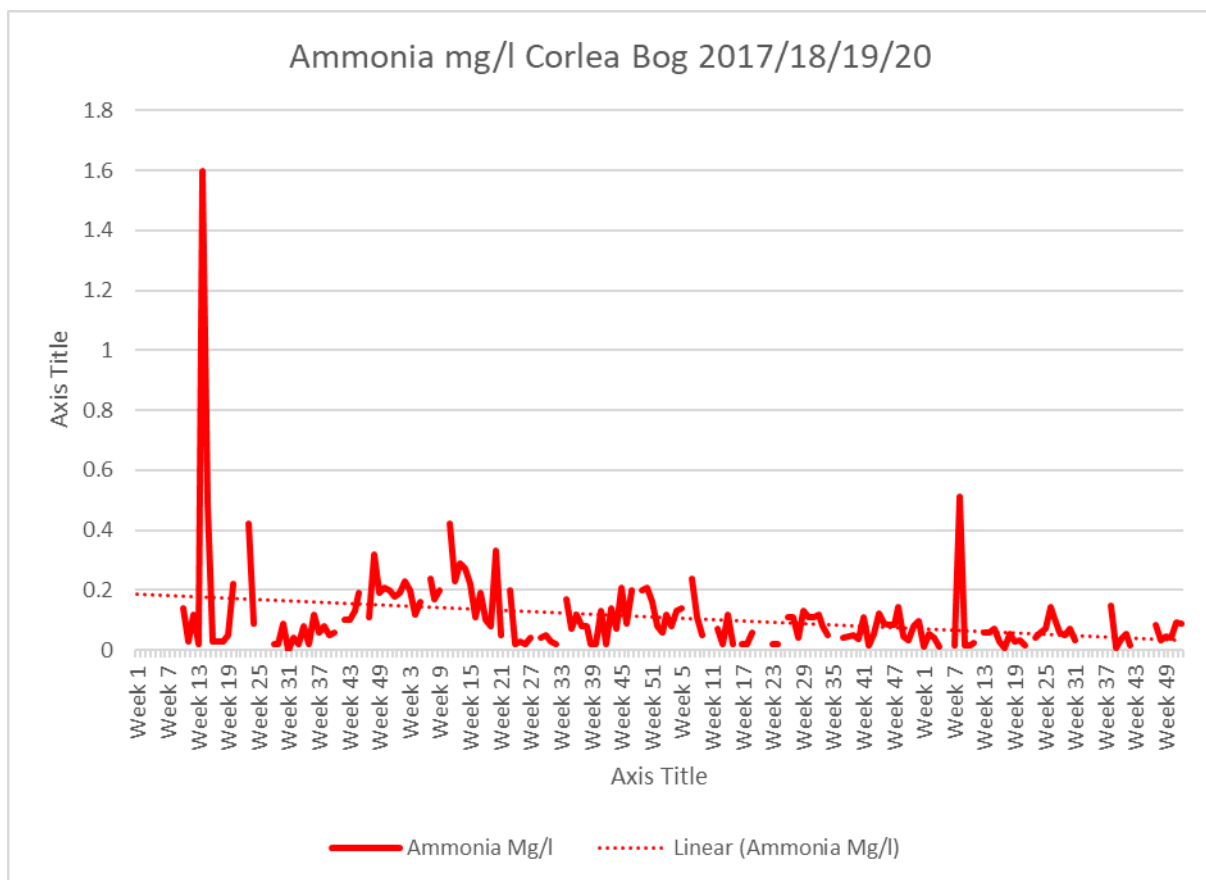
**Figure 7.1.** Ammonia levels over the period 2015-2019 at Longfordpass and the period 2017-2020 at Corlea.

Similarly monitoring of surface water ammonia emissions from a Corlea bog in Mountdillon over the past 4 yrs. post cessation of peat extraction with ongoing rehabilitation, indicate downward trends.

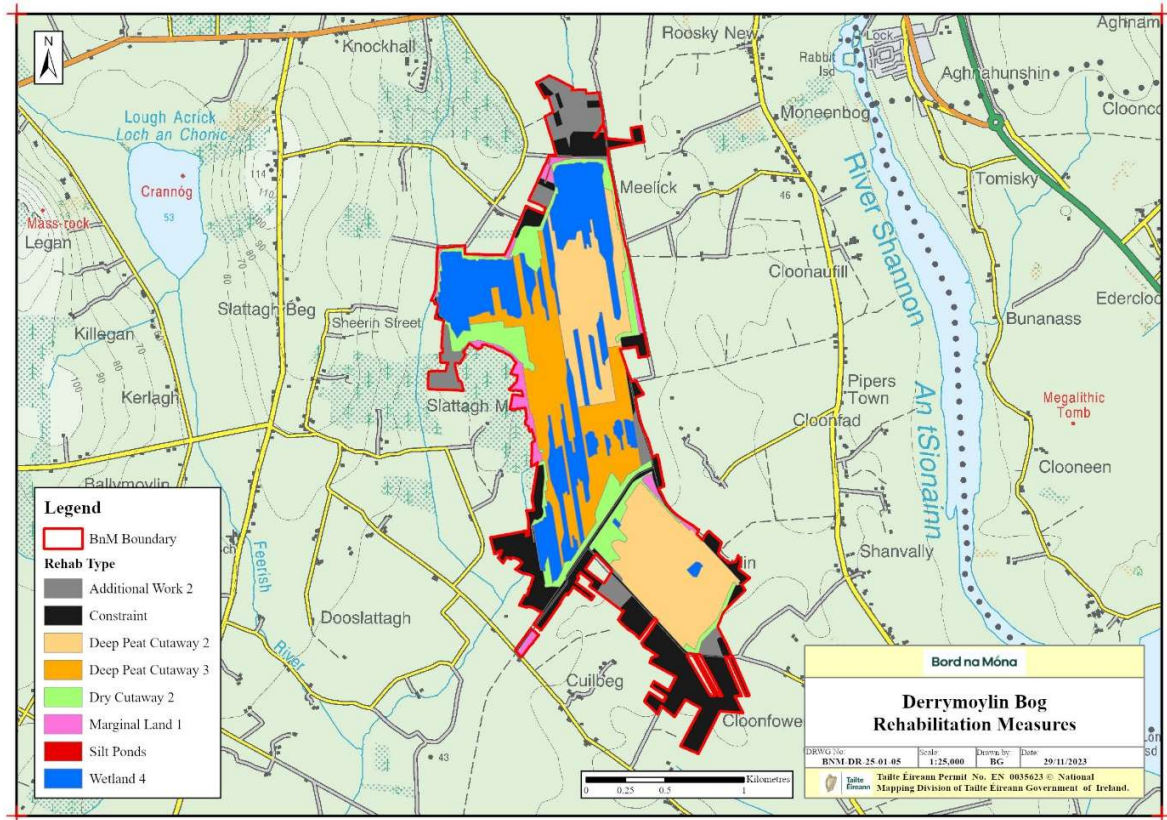
Fig. 1. Derrymoylin Bog, Co. Roscommon, the proposed rehabilitation measures.

Derrymoylin Bog is located c.1.5km southwest of Roosky, to the west of the L1415 road (see Fig 1). The bog rehabilitation area occupies the townlands of Derrymoylin, Drumman More, Cloonfower, Cuilbeg, Knockhall, Meelick and Slattagh More on OS 6-inch sheet Roscommon number 24.

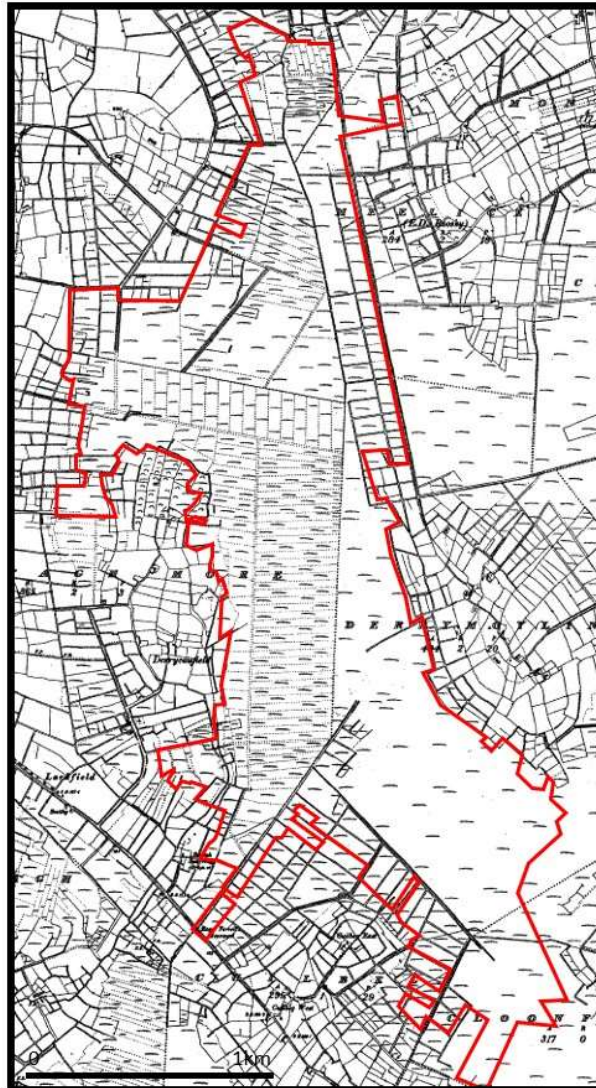
Fig. 2. Derrymoylin Bog, Co. Roscommon, detail of the Record of Monuments and Places map sheet Roscommon number 24. The proposed rehabilitation area is outlined with the red line.

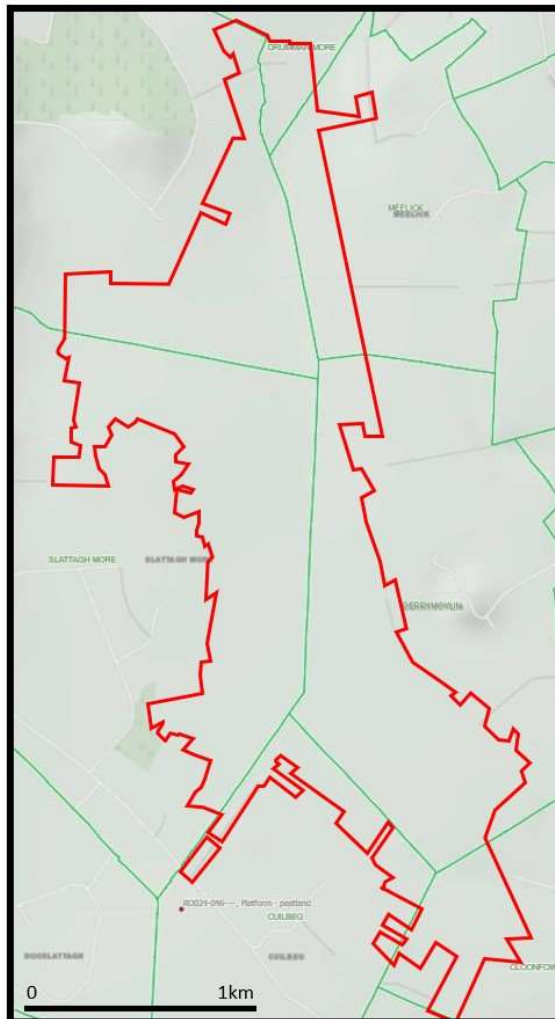
Fig. 3. Derrymoylin Bog, Co. Roscommon, detail of the Sites and Monuments Record. The proposed rehabilitation area is outlined with the red line.

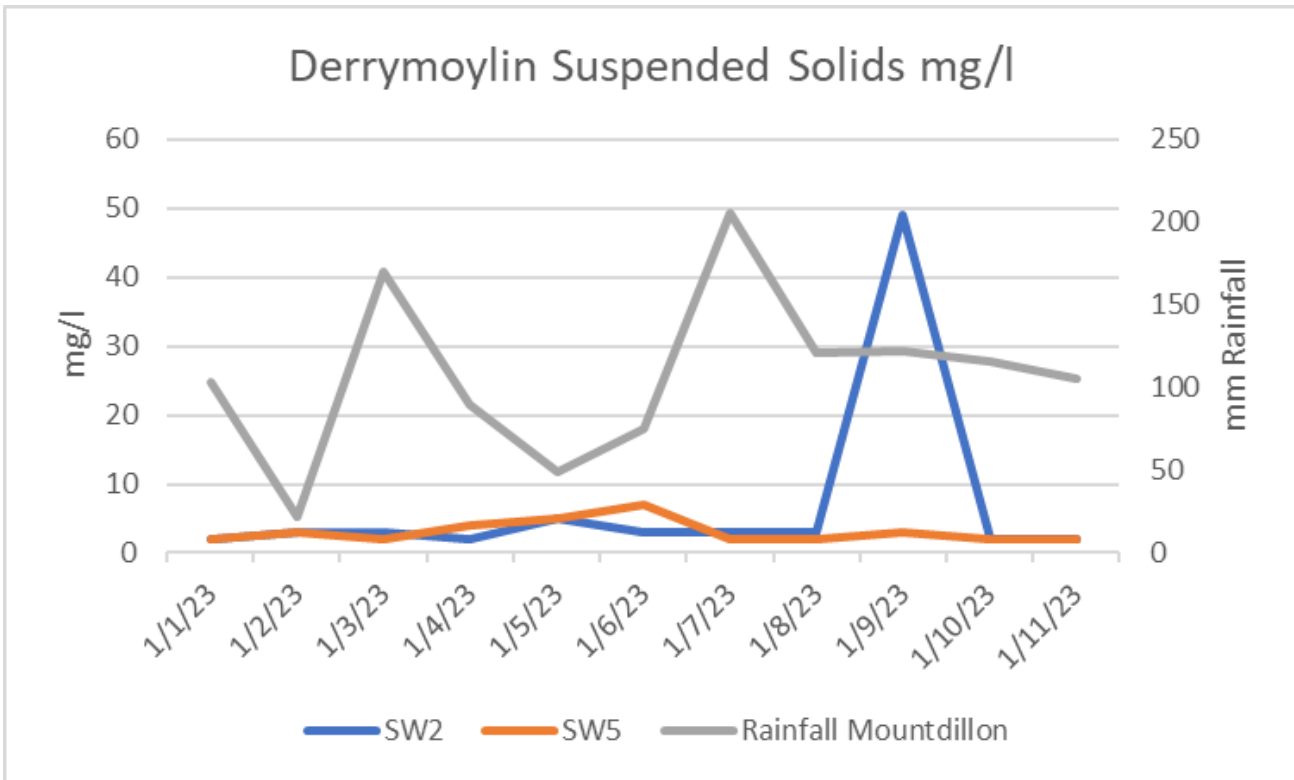
Plate 130-1 Derrymoylin suspended solids sampling results

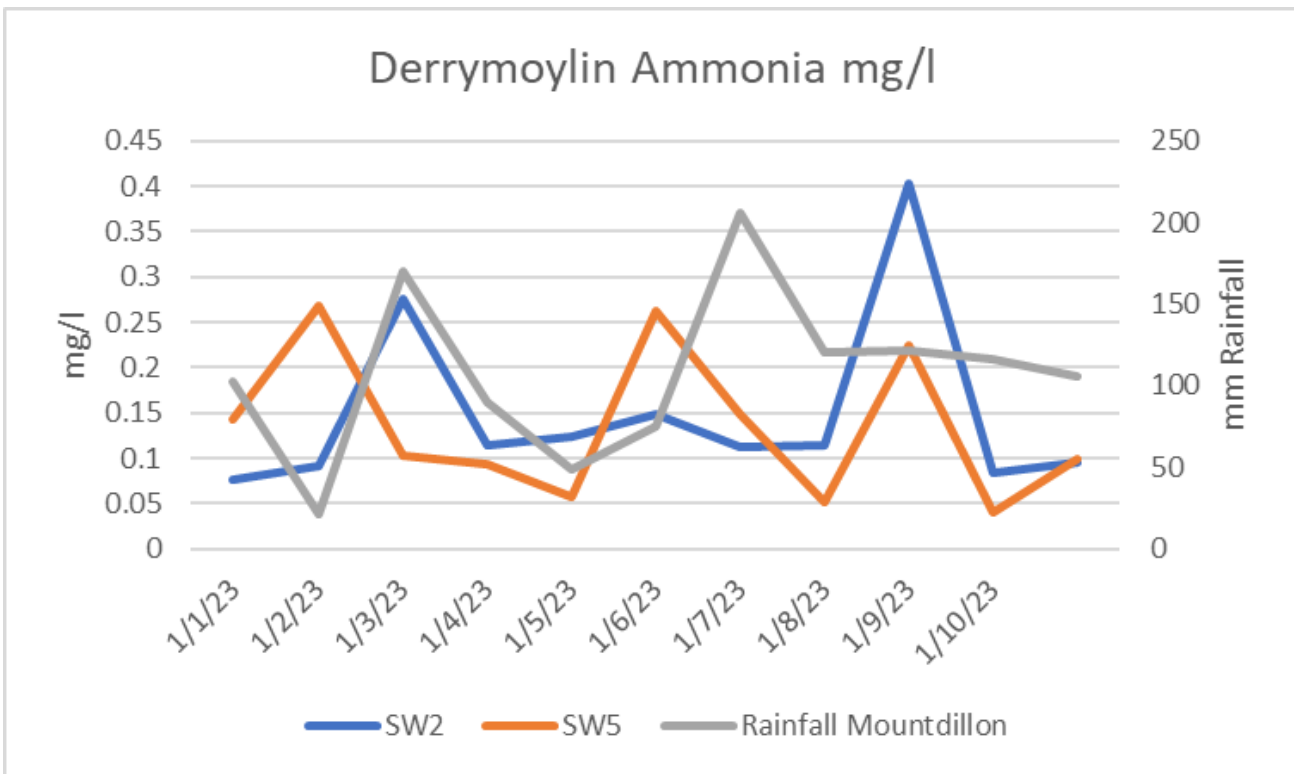
Plate 13-2 Derrymoylin Ammonia sampling results

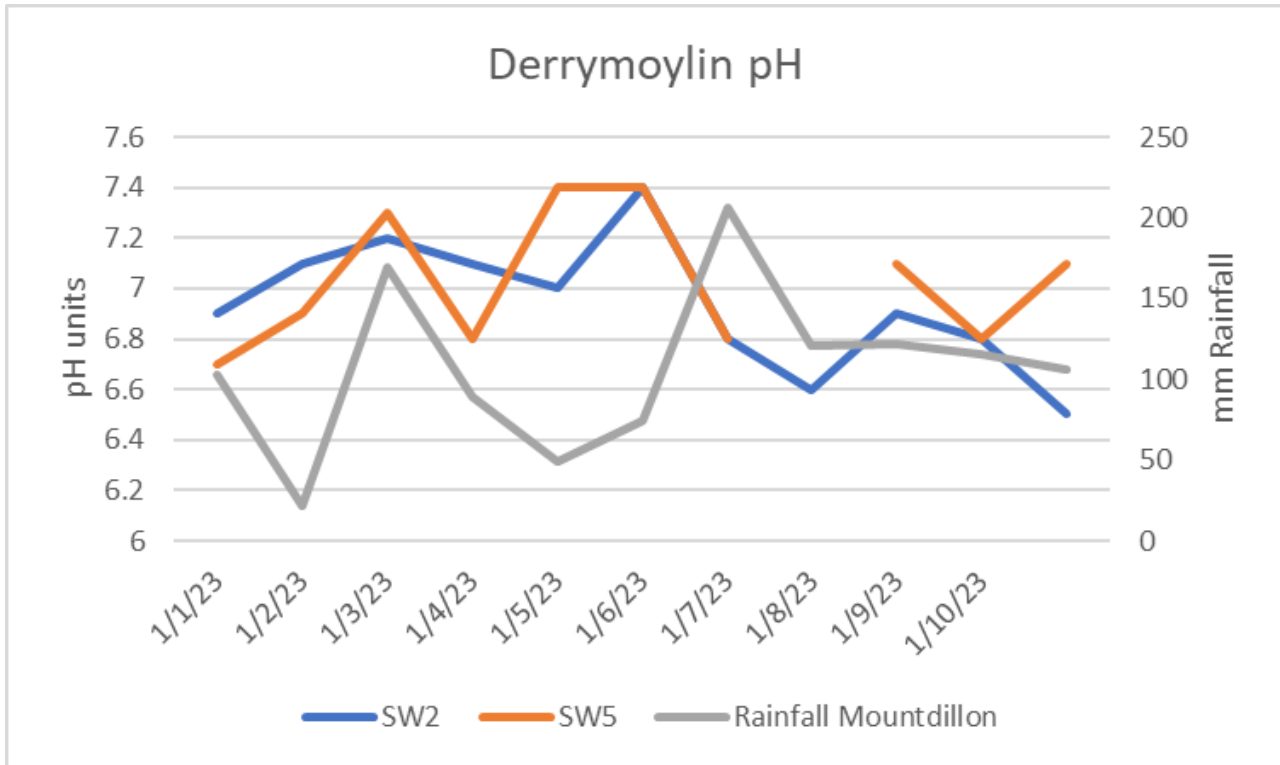
Plate 13-3 Derrymoylin PH sampling results
